Manhole Inspection Summary

Manhole # S09Q__003MH

Location Address: **3358 Strickland St.**

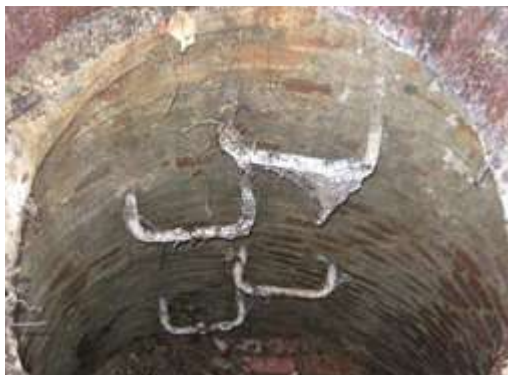
Misc infiltration

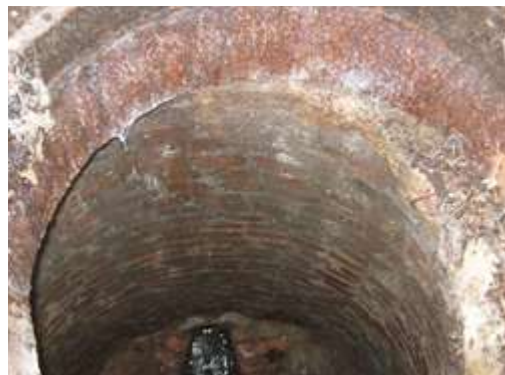
Defect 3

Infiltration: ☐ None ☐ Joint ☐ Cracks ☐ Mortar ☐ Roots ☒ **Wall**

chimney and corbel infiltration

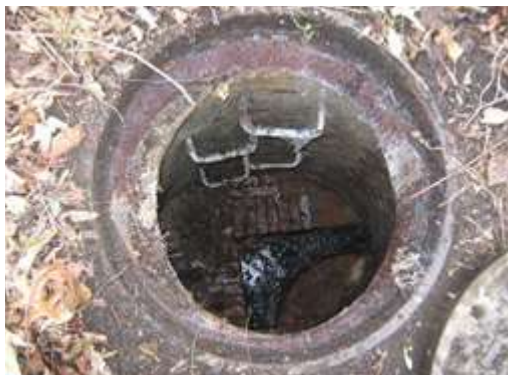
Defect 2

chimney and corbel infiltration

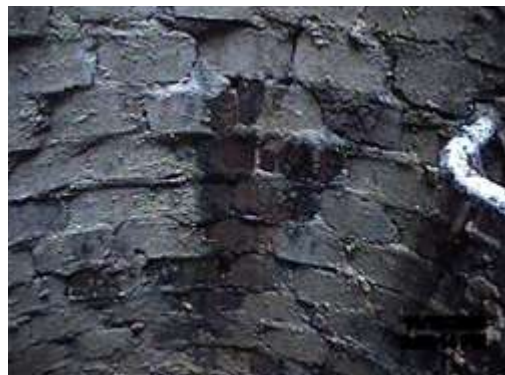
Defect 1

Frame Offset: **2** (in.) Condition: ☒ Sound ☐ Cracked ☐ Leaks

Steps Count: **4** Missing: **0** ☒ **Corroded**

frame offset & corroded steps

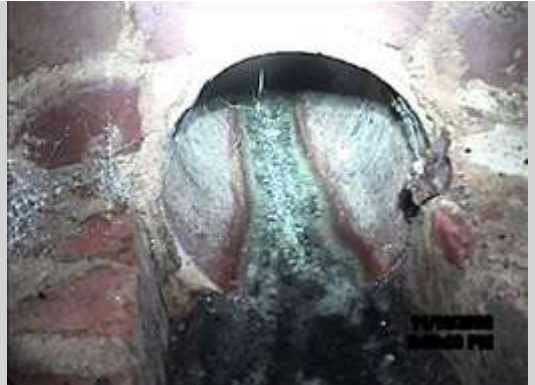
12 O'Clock Outflow

8 in. Circular Gravity Sewer
Pipe Out @ 12 O'Clock

Pipe Height: **8.4** (in.) Rod and Bar (Angled)
Pipe Material: **Clay** ☐ Pipe Lined
Invert Depth: **8.30** (ft.) Flow Characteristics: **None**
Deposits: ☒ None ☐ Mud ☐ Sludge ☐ Debris ☐ Grease
Silt Depth: **0** (in.) Deposits Extent:
Infiltration: **None** Pipe Seal Cond: **Sound**

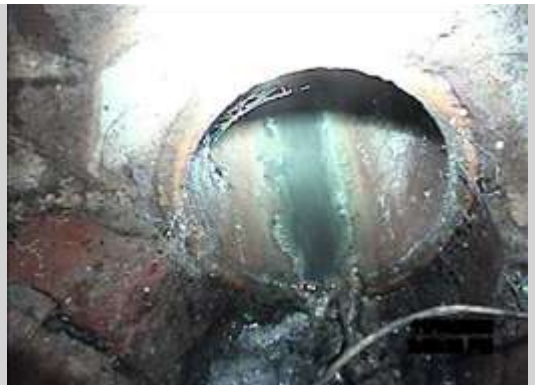
3 O'Clock Inflow

6 in. Circular Gravity Sewer
Pipe In @ 3 O'Clock

Pipe Height: **6** (in.) Rod and Bar (Angled)
Pipe Material: **Clay** ☐ Pipe Lined
Invert Depth: **7.81** (ft.) Flow Characteristics: **None**
Deposits: ☒ None ☐ Mud ☐ Sludge ☐ Debris ☐ Grease
Silt Depth: **0** (in.) Deposits Extent:
Infiltration: **None** Pipe Seal Cond: **Sound**
